Glen Providence County Park 3

Chapter 3: Glen Providence County Park

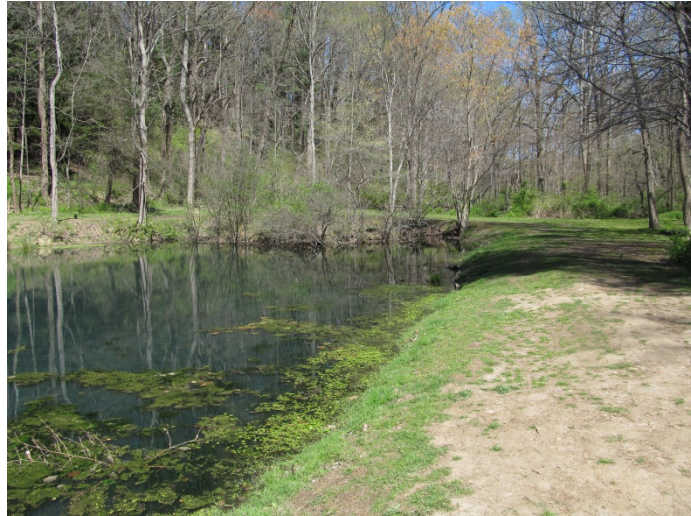
Figure 3-5: Broomall's Pond in Glen Providence County Park

Broomall's Pond is teeming with life. Several species of turtles, frogs and fish were observed within the pond. The turtle population was so dense that territorial behavior was observed between species. No turtle surveys were performed, but it did appear that the red belly slider and snapping turtle are among the species present. Minimal basking habitat exists within the pond. The turtles preferred the shallow upper portion of the pond. The lower portion of the pond was teeming with algae blooms. These blooms

are the result of excess nutrients, likely a result of a mix between animal waste and stormwater runoff. As this algae dies off and begins to decay, dissolved oxygen is consumed. This results in hypoxic or depleted oxygen conditions. Aquatic plants and animals cannot survive without sufficient oxygen. Hypoxic conditions are a greater threat during the warmer months of late summer during the peak algae bloom period.

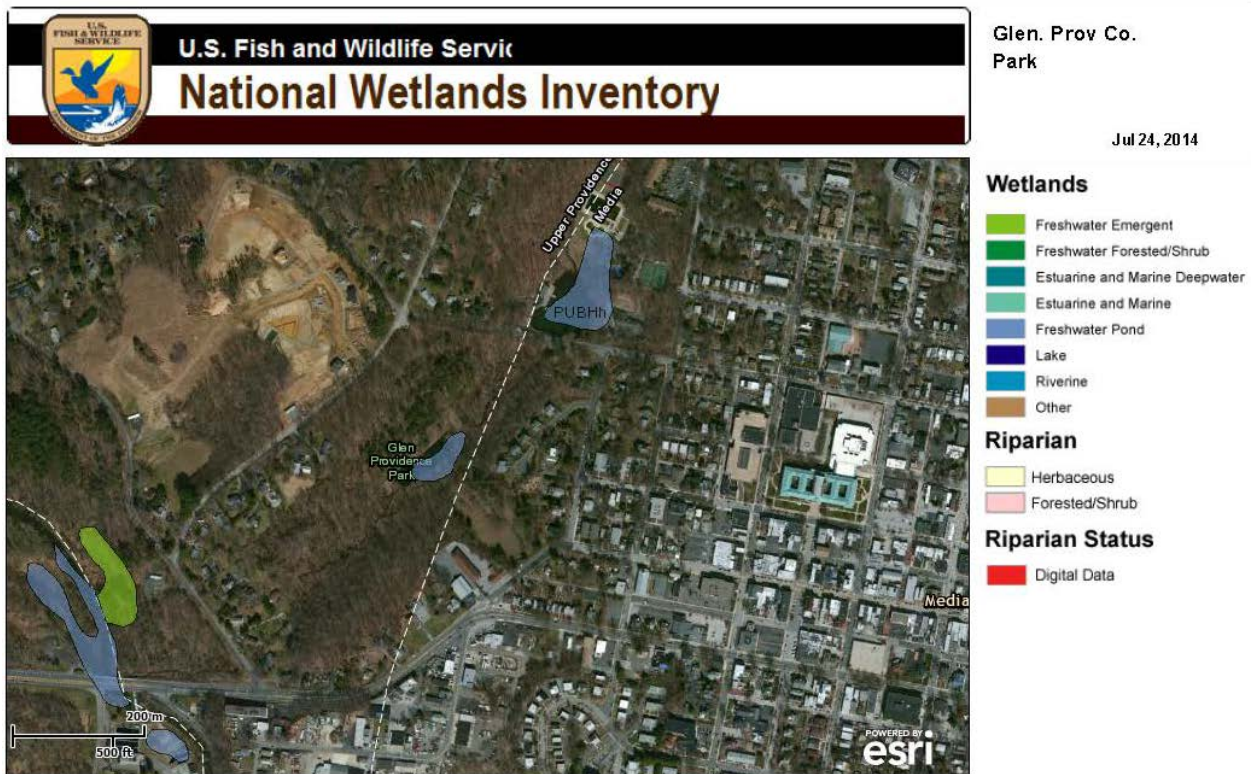
Figure 3-6: National Wetlands Inventory of Glen Providence County Park

No wetlands were found on National Wetland Inventory (NWI) mapping of the park. No wetlands were delineated or identified by the three parameter approach outlined in the 1987 United States Army Corps of Engineer Wetland Manual and corresponding regional supplement. A detailed wetland investigation was not practical for the level of detail for this survey report and NWI mapping often does not show smaller wetland pockets. Preliminary wetland investigation criteria used for the sake of this report consists of visual identification and rapid test of hydrophytic vegetation, landform and visible signs of hydrology. It is our conclusion that wetlands are most likely present all along the Broomall's Run corridor within the park. Also, a wetland area had been previously identified in the northern part of the park in the past planning efforts for the 3rd street dam. It is recommended that prior to any park improvements including land disturbance that a wetland investigation and updated Pennsylvania Natural Diversity Inventory (PNDI) inquiry be conducted to the presence of or potential habitat belonging to rare, threatened, and/or endangered species. A wetland investigation and, if necessary, wetland delineation may be required to be submitted with PADEP and NPDES permits for disturbances in wetlands and streams. The soils identified above are detailed further in Appendix G-1.

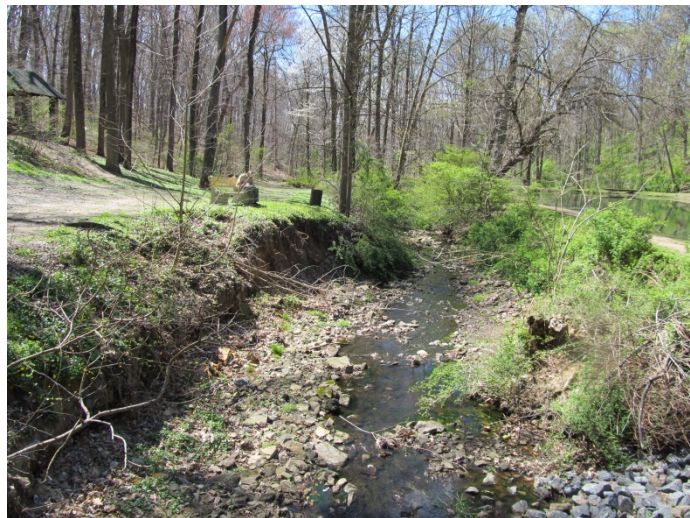
Figure 3-8: Stream channel in Glen Providence County Park

The riparian buffer of Broomall’s Run is well established, but invasive vegetation dominates in some areas. There are some areas of serious erosion along the Run, mainly in the area of Broomall’s Pond. At the pond, the Run is channelized around the east side of the pond. This concentrates and accelerates the flow causing major erosion. Also, at the pond’s discharge point, there are serious erosion problems (see photos). These issues must be addressed with the development of the park.

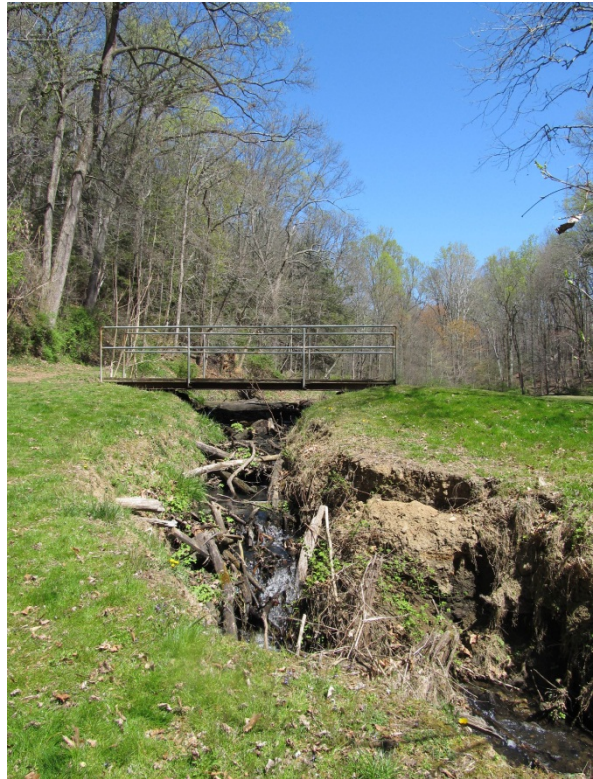
Figure 3-9: Pond discharge in the park

Broomall's Run flows through the valley toward the southwest. Unnamed Tributaries to Ridley Creek are designated as a High Quality Trout Stocked Fishery (HQ-TSF) by the Pennsylvania Department of Environmental Protection's (PADEP) Chapter 93 Water Quality Standards.

HQ waters have special protections and are defined as "Surface waters having quality which exceeds levels necessary to support propagation of fish, shellfish, and wildlife and recreation in and on the water by satisfying § 93.4b(a)" according to PADEP's Chapter 93 guidelines. Designated use of a TSF is defined as "Maintenance of stocked trout from February 15 to July 31 and maintenance and propagation of fish species and additional flora and fauna which are indigenous to a warm water habitat." Despite the HQ-TSF designation, the aquatic life status has a pending impairment status by PADEP because of urban runoff causing flow variation, siltation, thermal modifications and flow alterations.

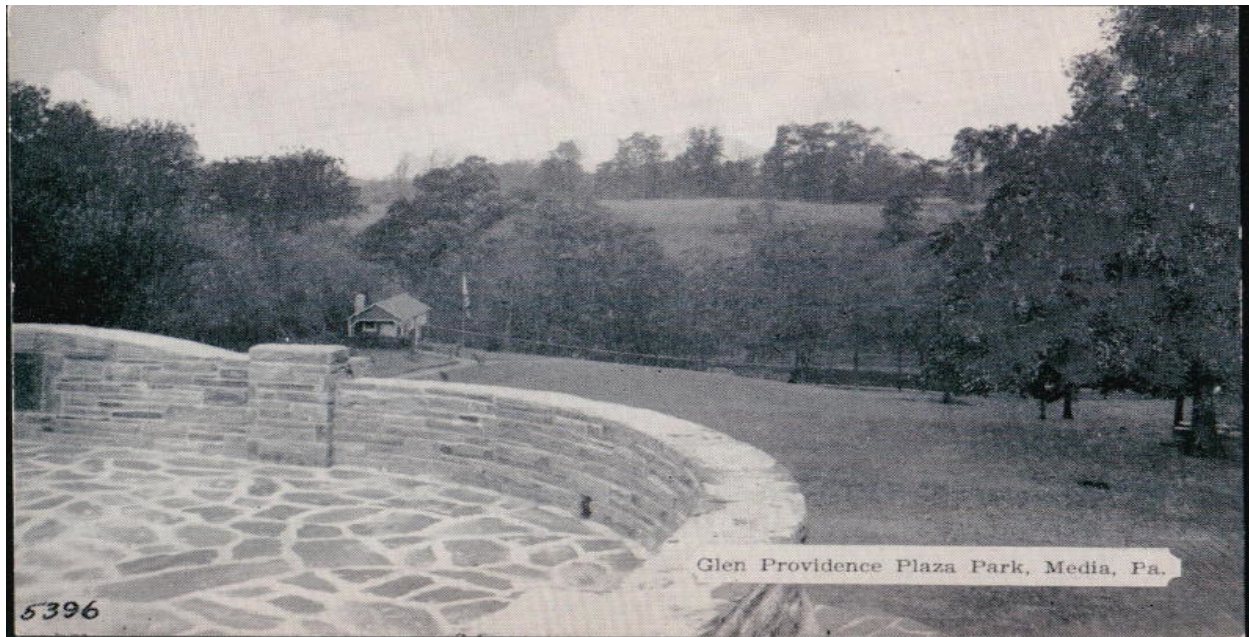
Figure 3-18: Overlook structure (date unknown)

The “Glen Providence Plaza” was one of the original structures built for the park and still stands as a beacon watching over Glen Providence Park.

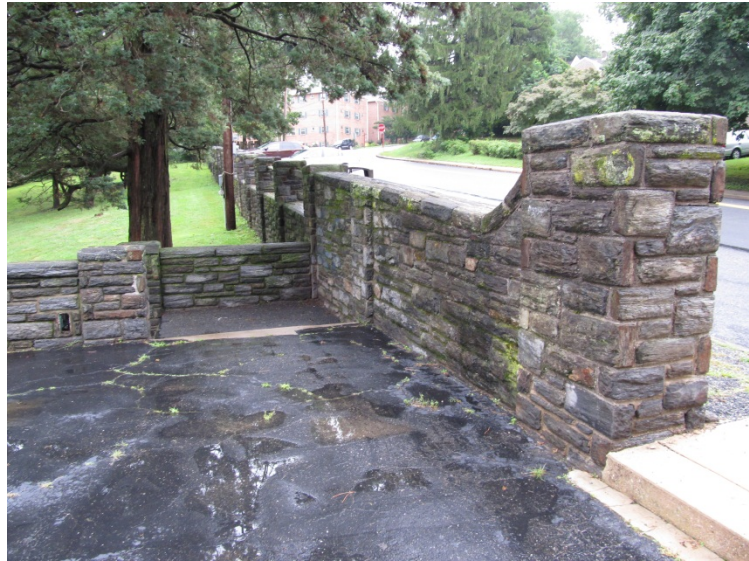
Figure 3-20: Overlook structure entrance

Stone Masonry and concrete construction. The structure is not in use and currently all openings are sealed with masonry. The interior space is inaccessible. Presently it is impossible to assess the condition of the interior and the structure, but based on the condition of the roof terrace surface, it seems safe to conclude there is likely significant damage to the interior due to water intrusion. The original roof terrace surface, probably slate or flag stone, is covered with a bituminous coating that has cracked over the years and allows water to penetrate into the construction. The stone masonry

forming the walls and the flanking stairs appears to be in relatively good condition. It's been reported the structure once housed restroom facilities. It's appropriate to reconsider using the structure to provide these facilities again and possibly add concession sales to support activities at the park. Based on assumptions about the condition of the interior, this would likely be a costly reconstruction. Even assuming the interior construction is structurally sound and that what remains of the original interior is damaged beyond restoration, the primary issue is restoring a serviceable roof terrace construction. In order to do this the best approach is to strip the terrace of all existing finishes to the structural roof deck and develop a new roofing/terrace construction system that provides suitable protection of the interior, drains well and creates an appropriate and attractive terrace surface. Other work would include:

- Cleaning and some repointing of the stone.
- Resetting loose stair treads.
- New windows and doors with security shutters.
- New mechanical and electrical systems including services.
- New fixtures, interior partitions, and finishes.

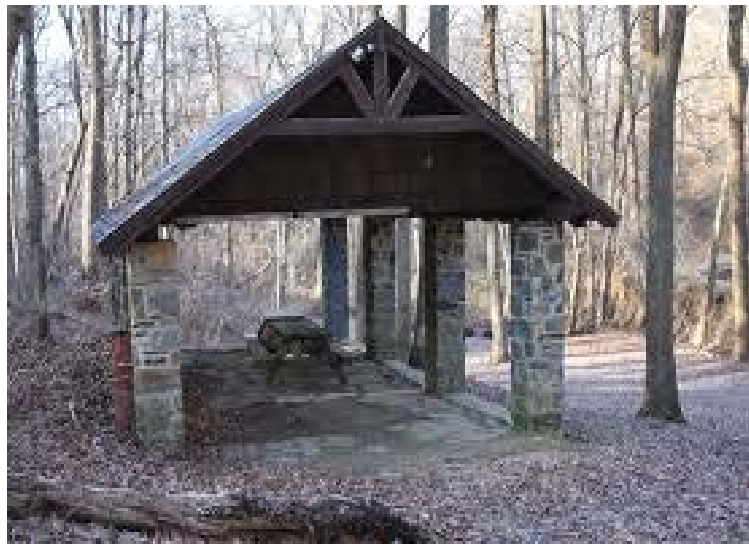
Figure 3-21: Pavilion

Wood timber construction on stone piers, in general, the pavilion appears to be in fair condition and in need of general maintenance type repairs including painting, new flooring surface and roofing replacement.

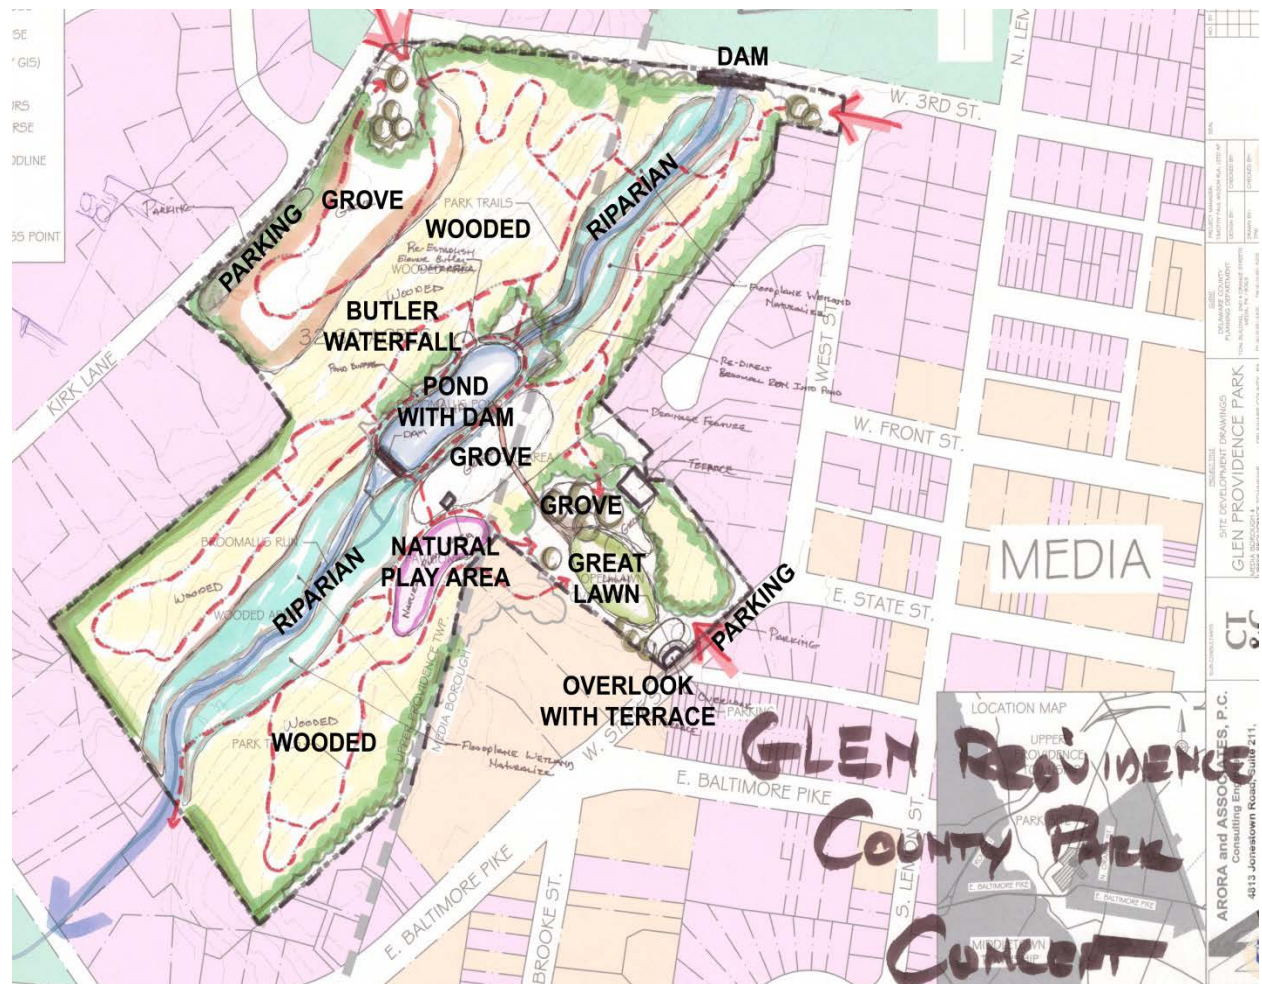
Figure 3-23: Glen Providence County Park Concept Sketch

The concept of the Glen Providence County Park Site Development Plan is to keep the park natural and passive while making the necessary improvements to sustain functionality and celebrate the natural landscape and history. The concept places emphasis on preserving the passive nature of the park while enhancing the user experience through interpretation and environmental education.

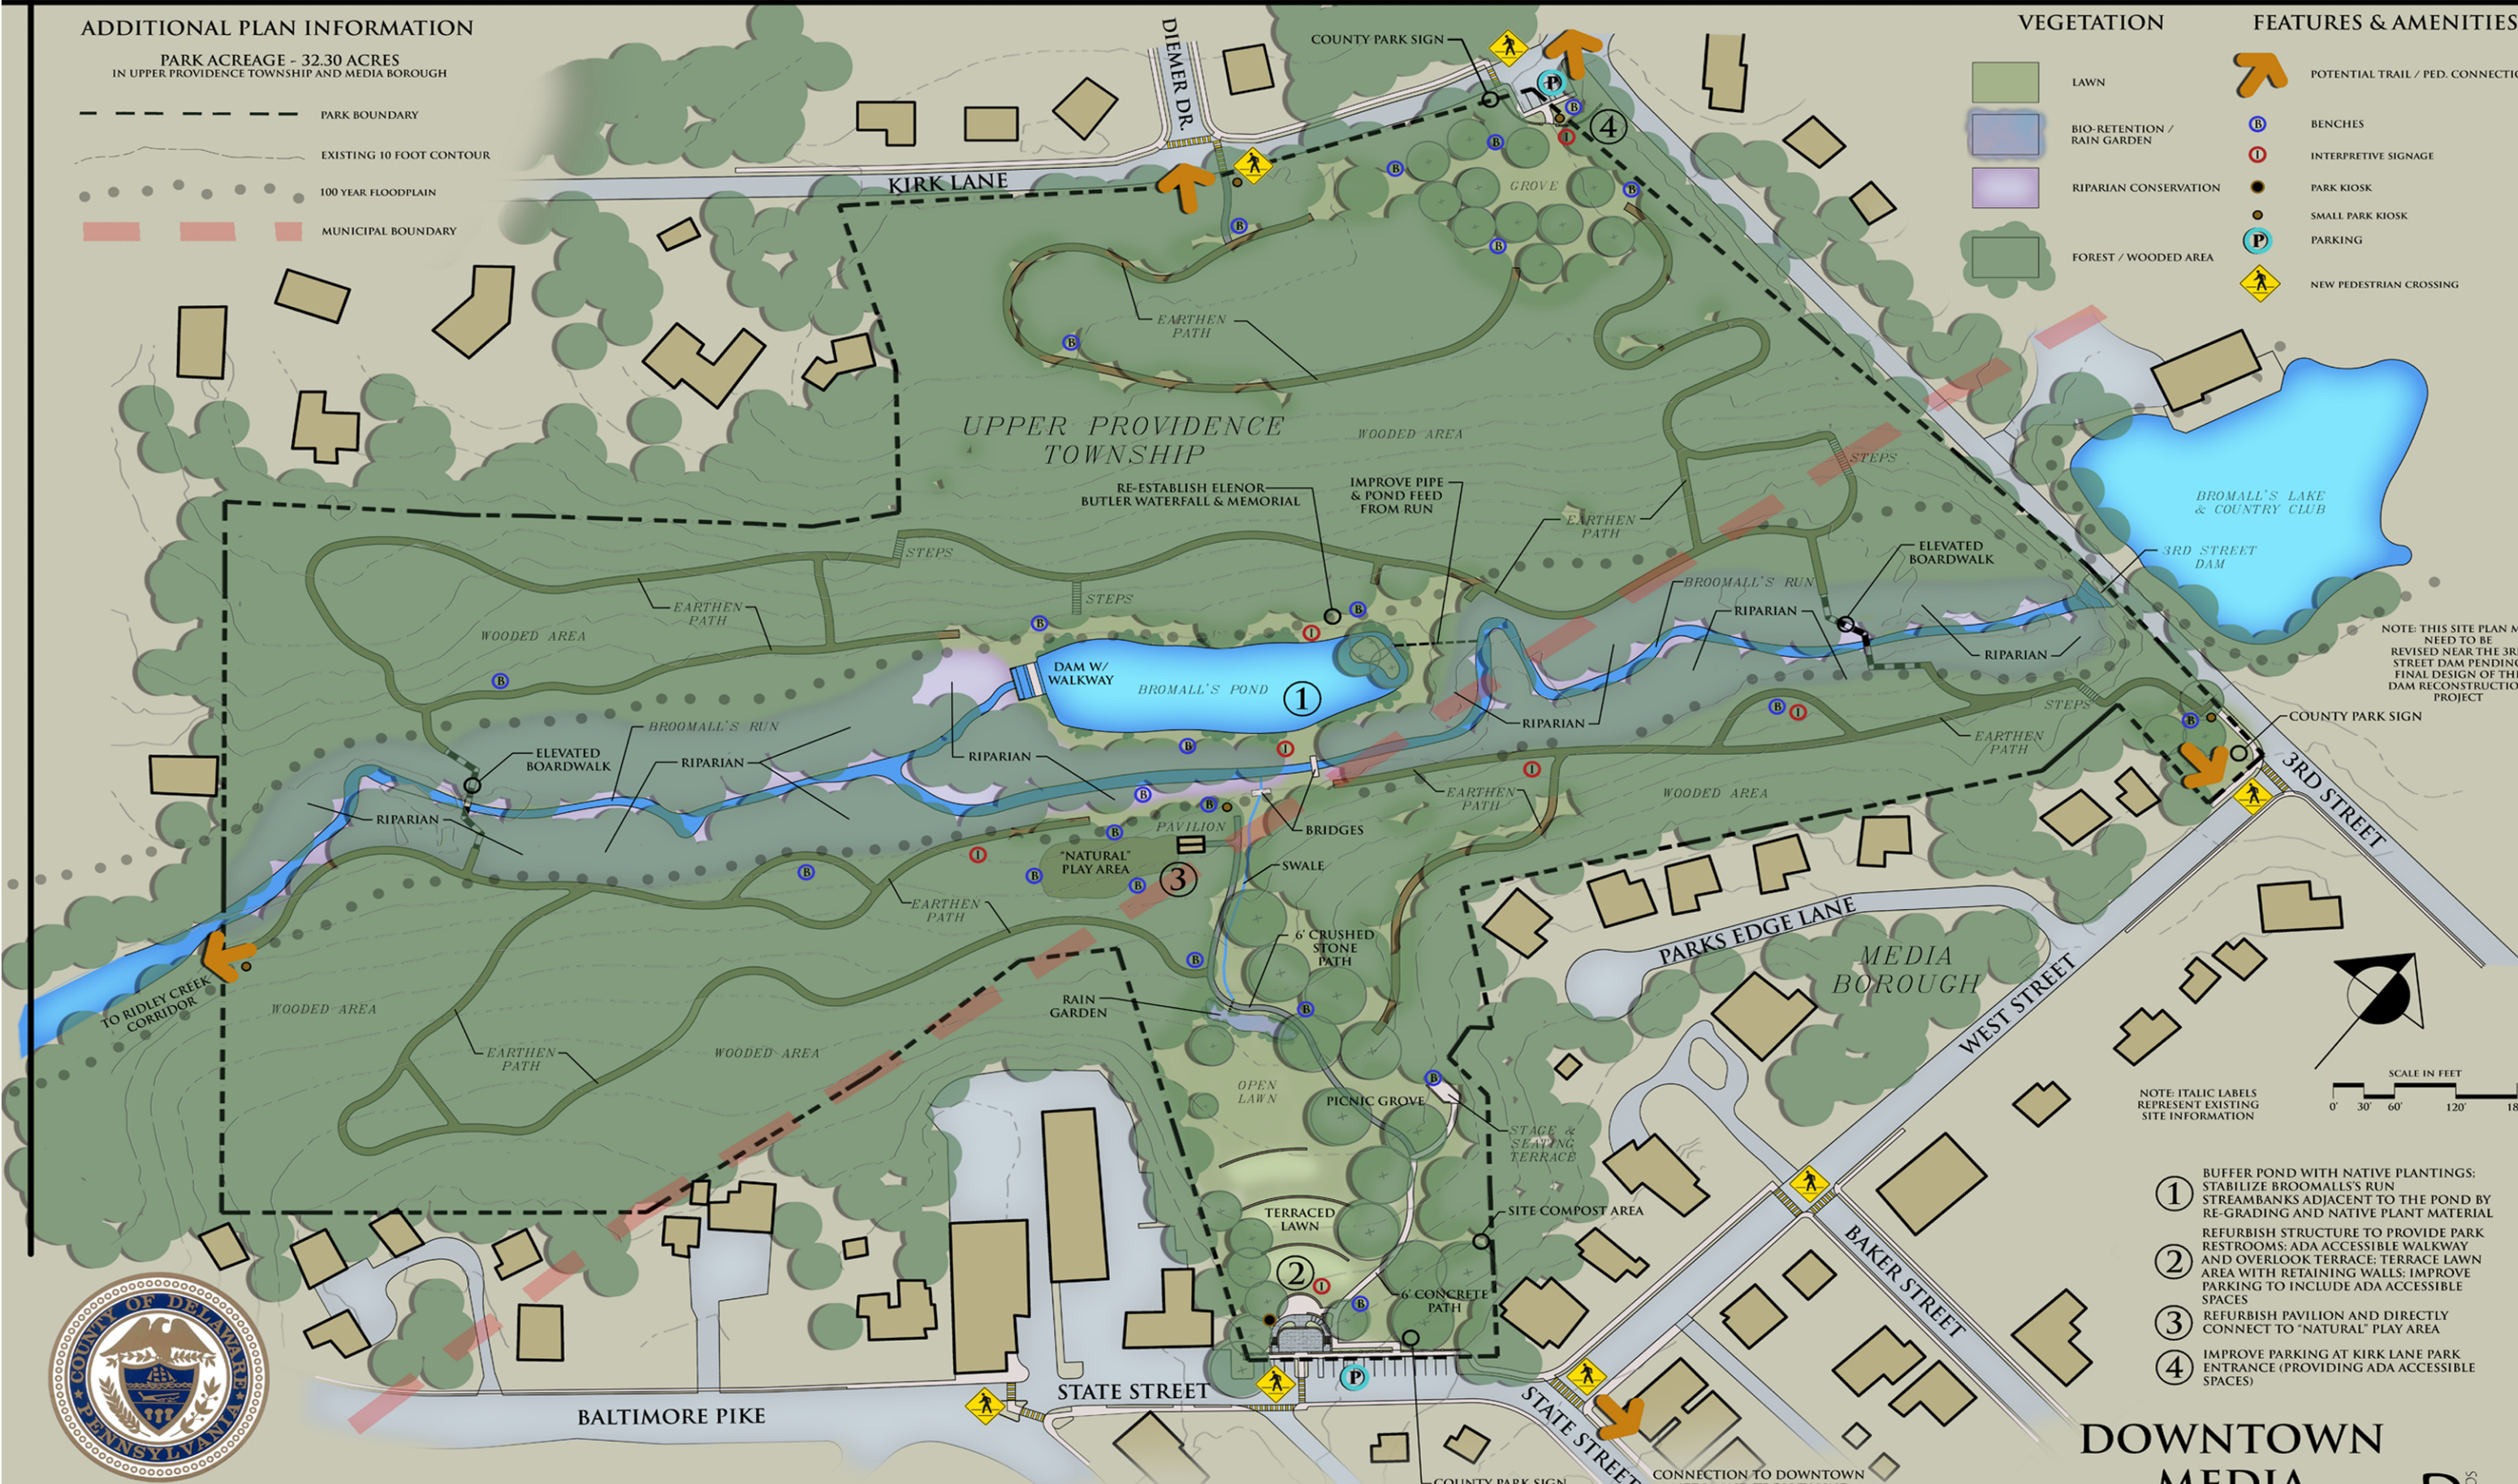
The site development plan is an illustrative rendering of Glen Providence County Park that reflects the recommended improvements at full park “build out.” The plan incorporates all phases of development including “long-range” concepts.

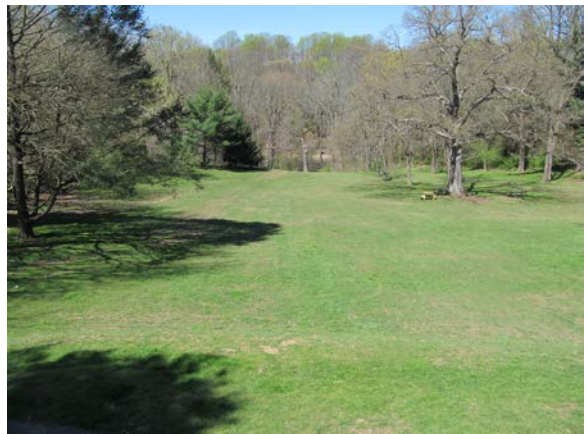
A steeply sloping partially wooded turf grass meadow is the first area visitors see upon entrance of the park. There is some erosion occurring at the toe of slope at the transition to the wooded stream valley. This erosion is due to grading and lack of vegetation to disrupt/infiltrate surface flows. Erosion matting and bare soils are exposed.

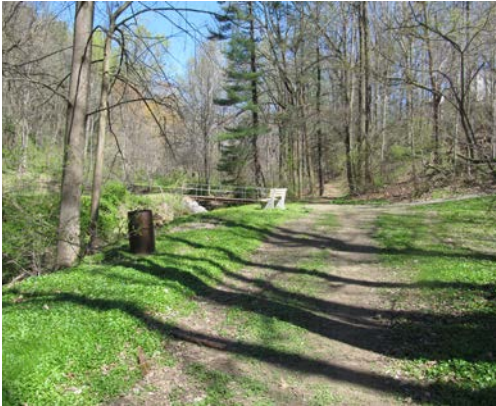
A pipe located along a sharp meander diverts a portion of the creek's flow into the pond. The creek channel has been diverted along the south east edge of the pond and runs at the base of the berm/levee of the pond. Portions of this channel are showing signs of active degradation. The most severe are occurring at the meander around the upstream portion of the pond, at the toe of slope from the meadow at a stormwater outfall, a portion undercutting the pond berm, and at the pond outfall. A vertical bank has eroded along the meander upstream of the pond. The channel appears to have migrated towards the

pond. This horizontal channel shift is likely attributable to the multiple flood events that occurred during the month of September 2011. Further downstream there is severe bank erosion occurring at the toe of slope of the wood clearing and subsequent path leading from the meadow to the forested valley floor. (*Note: Emergency repairs were undertaken to the streambank of Broomall's Run adjacent to the Pond in the spring of 2014*). The origins of this degradation are from the surface runoff from the cleared slope and from a stormwater pipe outfall. Riprap was placed along this area for protection. However, it is currently failing. Active undercutting of the pond berm is occurring along the northeast bank approximately 40' downstream of the pedestrian bridge over Ridley Creek. This is a threat to the pond infrastructure. Horizontal and

vertical migration of the stream channel was observed downstream of the pond outfall. Woody debris was observed within the pond outfall channel to raise the bed elevation and reduce vertical drop. A headcut is occurring downstream of the woody debris. Braided channels are located below the headcut.
